Land Characteristics, Run-Off and Potential for Rainwater Harvesting in Semi-Arid Areas of Tanzania

Rwehumbiza, F.B.R^{1*}, N. Hatibu² and M. Machibya

Abstract

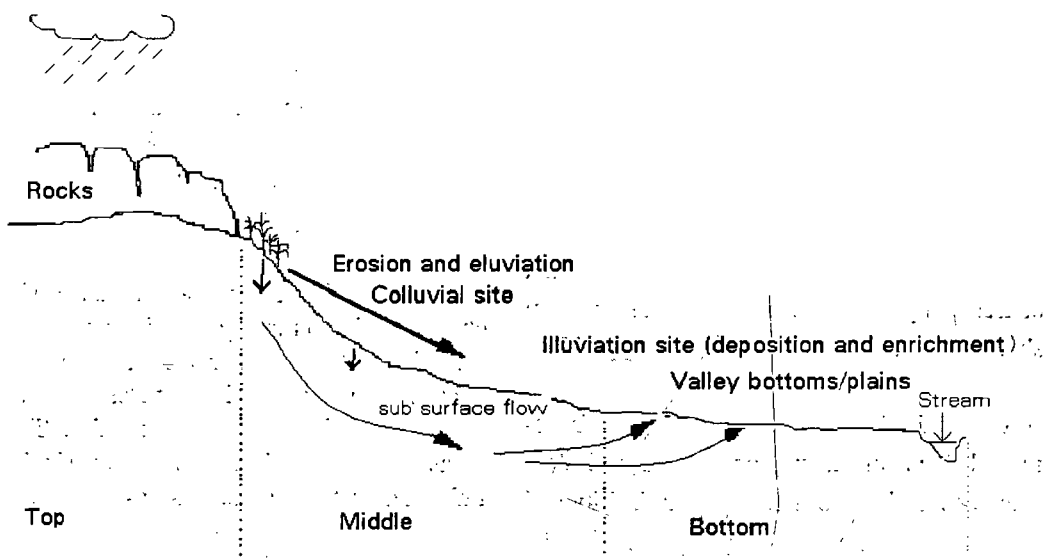
Figure 1: Water movement in a generalised catena

A catena is considered as a natural set-up for land use planning and hence for rainwater harvesting. The top section acts as a natural generator of runoff and the bottom two sections act as natural receivers (Figure 1). Important land characteristics on the catena include soil type, hydraulic properties down the profile, soil variation along the toposequence, slope and vegetation cover. The relative proportions of the three sections in a given catena, how they are used and managed, determine the amount of runoff, erosion and the potential for rainwater harvesting (RWH). The top, middle and bottom parts of the catena may vary greatly in their relative sizes.

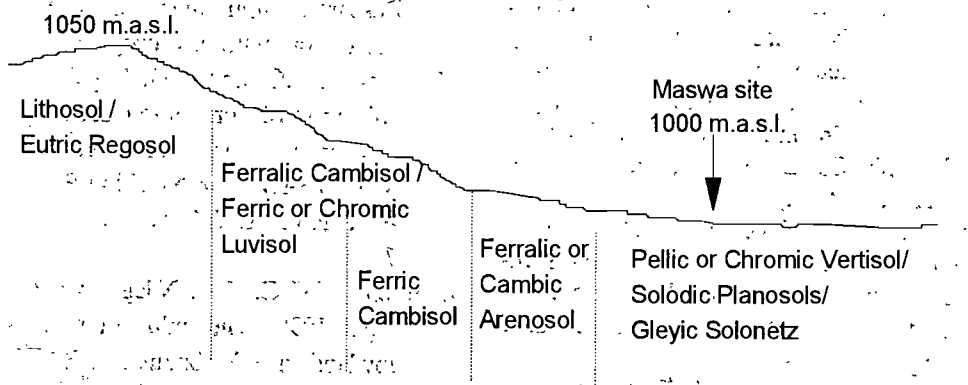
Figure 2(c): A catena across Shishiyu Maswa (constructed with information from Meertens *et al.*, (1999), Mahoo *et al.*, (1998), Ngailo *et al.* (1994) and, De Pauw (1984)

Unlike the WPLL and Morogoro cases, which have very steep mountains overlooking the lowlands, this area has small hills that cover relatively small areas compared to the extensive plains (Figure 2(c)). Rainwater harvesting is wide spread, and most runoff is harvested into banded paddy fields. The generated run-
